Manhole Inspection Summary

Manhole # S17Y__013MH

Insp Date: **6/3/08 1:04 PM**

Location Address: **2514 james st**

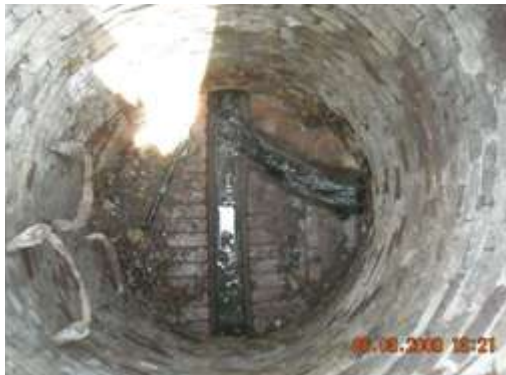
misc

bench debris

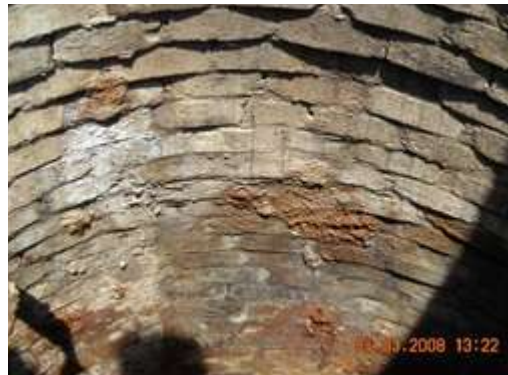
Defect 3

Infiltration: ☐ None ☐ Joint ☐ Cracks ☐ Mortar ☐ Roots ☒ **Wall**

infiltration @ barrel wall

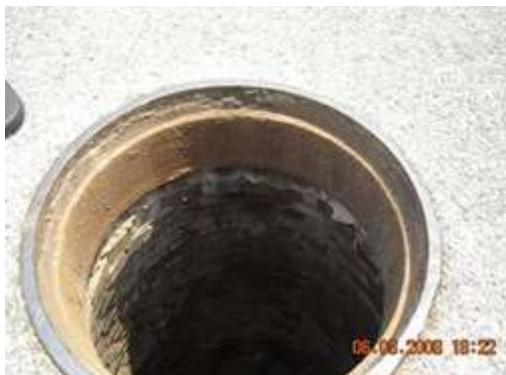
Defect 2

Subject To Ponding: **Sheeting**

inflow evidence from sheeting

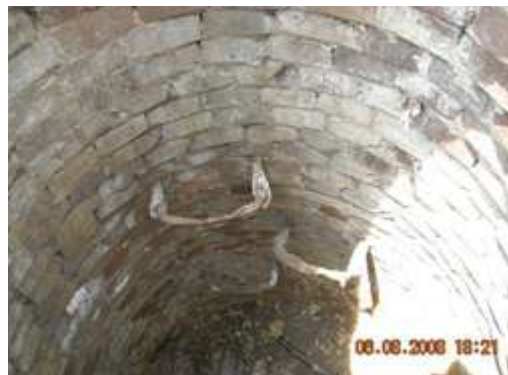
Defect 1

Count: **3** Missing: **1** ☒ **Corroded**

corroded & missing steps

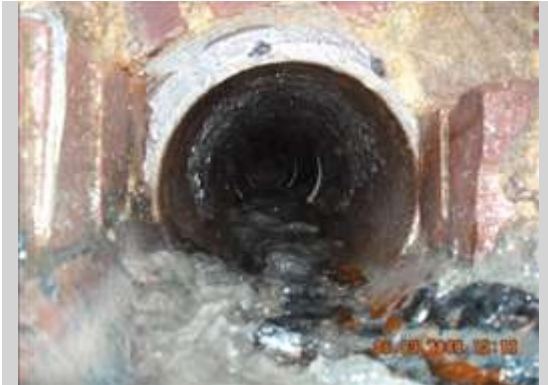
12 O'Clock Outflow

Pipe Height: **8.4** (in.) Rod and Bar (Angled)
Pipe Material: **Clay** ☐ Pipe Lined
Invert Depth: **8.46** (ft.) Flow Characteristics: **Slow**
Deposits: ☒ None ☐ Mud ☐ Sludge ☐ Debris ☐ Grease
Silt Depth: **0** (in.) Deposits Extent:
Infiltration: **None** Pipe Seal Cond: **Sound**

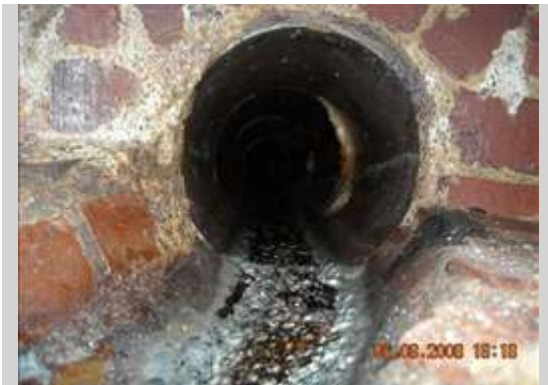
3 O'Clock Inflow

Pipe Height: **8.4** (in.) Rod and Bar (Angled)
Pipe Material: **Clay** ☐ Pipe Lined
Invert Depth: **7.90** (ft.) Flow Characteristics: **Slow**
Deposits: ☒ None ☐ Mud ☐ Sludge ☐ Debris ☐ Grease
Silt Depth: **0** (in.) Deposits Extent:
Infiltration: **None** Pipe Seal Cond: **Sound**

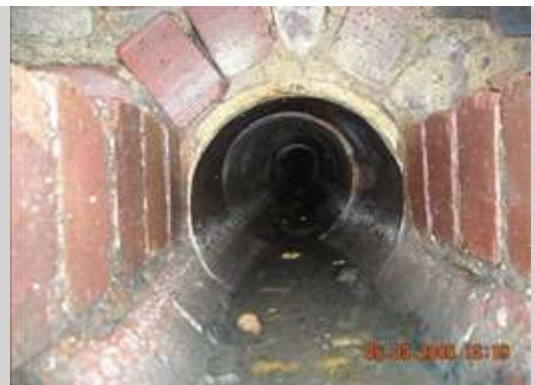
6 O'Clock Inflow

Infiltration: **None** Pipe Seal Cond: **Sound**
